DETECTING AND PREDICTING MW WIND TURBINE DRIVE TRAIN FAILURES

David Clark
Director, Turningpoint/Commtest

3 COMMON EXAMPLES OF MW WTG ISSUES

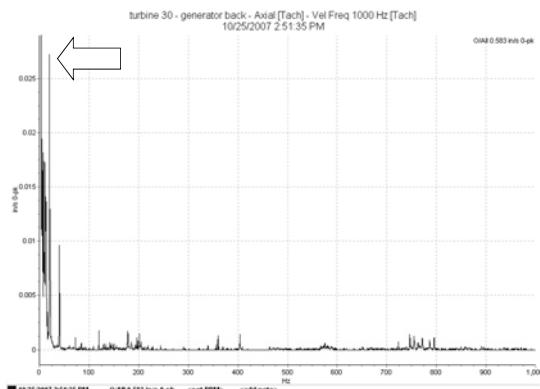
EXAMPLE # 1

- Misalignment of a Megawatt class wind turbine
 - Gearbox to generator
 - Shows as a high peak at the running speed
 - First vibration signature shows .5 amplitude in a velocity measurement (before)
 - Second shows .025 amplitude after alignment (after)

BEFORE .5

High amplitude at running speed
←

AFTER .025

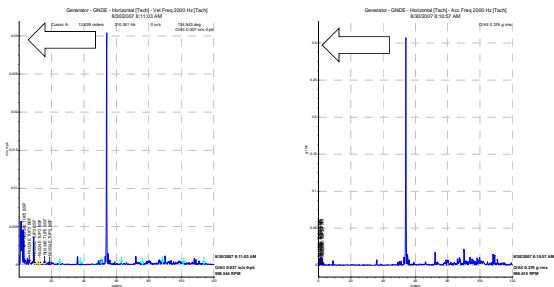
GOOD(.03) vs. BAD(.3) Generator Bearing

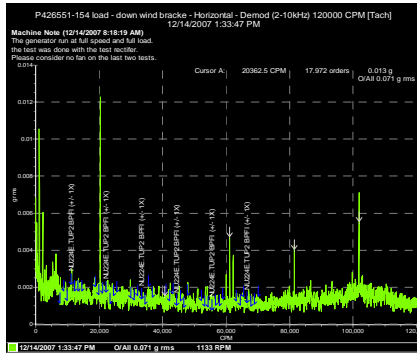
**VIBRATION SIGNATURE IS LABELED WITH
BPFI
(INNER RACE DEFECT)**

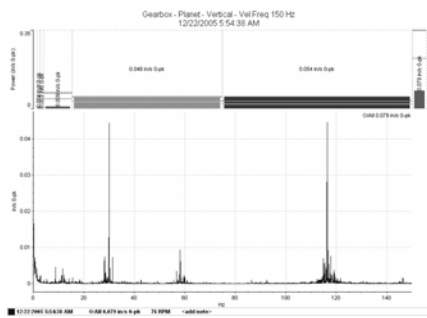
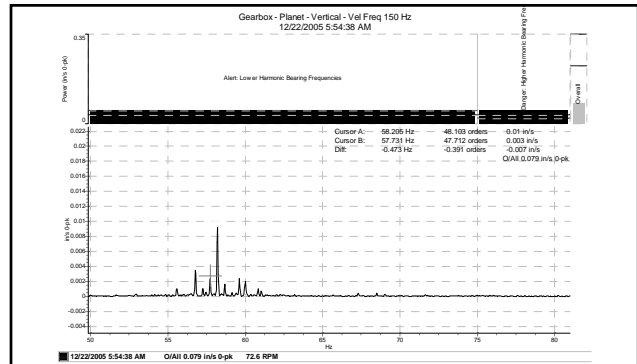
PLANETARY GEARBOX SIGNATURES

- Data captured on stage 2 mesh on the planet at 2:54 p.m.
- Again, the problem appears to be with very early stages of gear wear on the carrier. No other faults were noted.
- As levels of vibration in all these tests seem quite low, and there is no substantial alarming; it is safe to conclude that we are seeing only early stages of wear in the gearboxes that require no immediate action, but warrant more frequent monitoring.
