DETECTING AND PREDICTING MW WIND TURBINE DRIVE TRAIN FAILURES

David Clark
Director, Turningpoint/Commtest

3 COMMON EXAMPLES OF MW WTG ISSUES

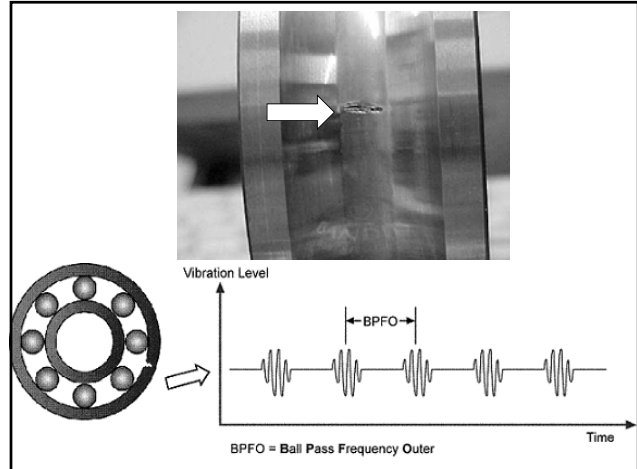
- BEARING FAULT IN A MEGAWATT CLASS WIND TURBINE
- COMMON BEARING ABBREVIATIONS
 - BPFO (outer race defect)
 - BPFI (inner race defect)
 - FTF (cage defect)
 - BSF (rolling element defect)
- There are 2 ISO standards for alarms and 1 widely accepted 30 year study also used for alarming

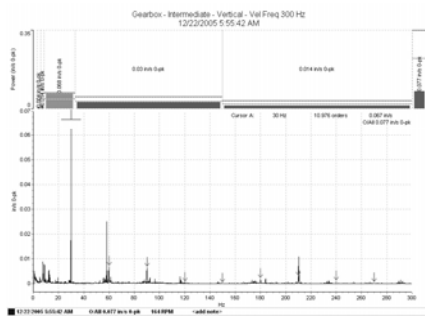
AMPLITUDE = SEVERITY

PROGRESSION OF THE FAILURE

- TYPES OF VIBRATION MEASUREMENTS INDICATE THE FAILURE PROGRESSION OF THE COMPONENT. *“VELOCITY”* AND *“DEMODULATED”* MEASUREMENTS GIVE AN APPROXIMATE TIMELINE

How do I interpret the results? Look for peaks at known bearing fault frequencies in both the normal vibration velocity spectra and the demodulated spectra.

No peaks in either spectrum: Condition is good, use as a baseline for future comparisons.

Peaks appear in Demod only: Early warning indication that defects exist (or the bearing needs lubrication).

Peaks appear in Velocity and Demod spectra: Plan replacement at next maintenance period.

Peaks appear in Velocity spectra only, combined with a rise in the Demod noise floor: Replace the bearing now!

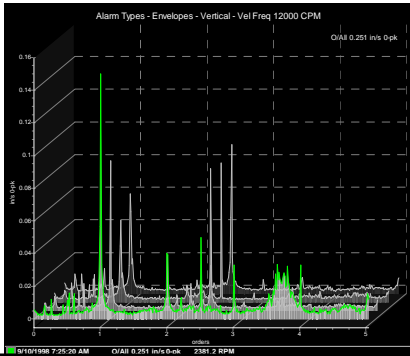
WIND TURBINES ARE VERY EASY TO COMPARE TO EACH OTHER TO DETERMINE A FAULT

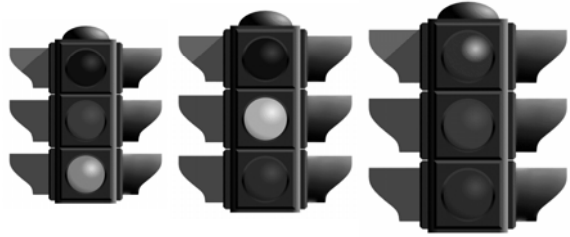
VIBRATION ANALYSIS INTERPRETATION IS REDUCED TO *TRAFFIC SIGNALS* WITH ALL MAJOR CONDITION MONITORING SUPPLIERS

GOOD(.03) vs. BAD(.3) Generator Bearing

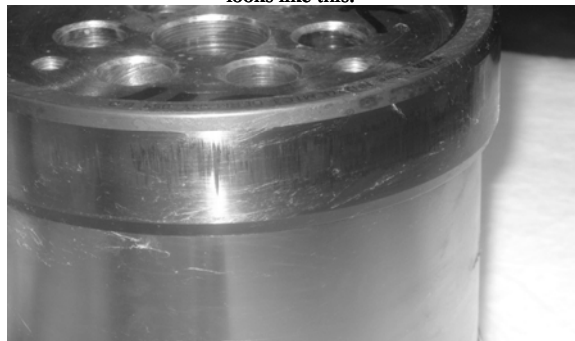
MEGAWATT GENERATOR BEARING

**VIBRATION SIGNATURE IS LABELED WITH
BPFI
(INNER RACE DEFECT)**
