THE UNIVERSITY OF IOWA
Department of Mechanical Engineering

Fracture Mechanics
ME:5159

Homework #3
Total Points: 20

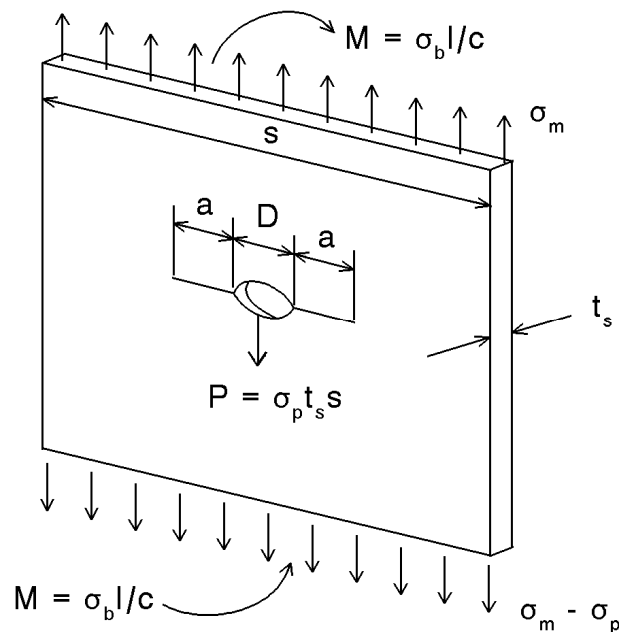
The design team of an aerospace company discovered cracks, approximately 4 mm (0.16 inch) long, emanating from each side of a circular rivet hole (Hole No. 6, see figure below) in a fuselage lap joint of a Boeing 747 aircraft. The fuselage skin is 2024-T651 aluminum with a plane strain fracture toughness of $40 \text{ MPa}\sqrt{\text{m}}$ ($36.4 \text{ ksi}\sqrt{\text{in}}$). From linear-elastic stress analysis, the membrane stress (σ_m), the fastener load (P), the local bending stress (σ_b) can be related to fuselage pressure, p , fuselage radius, R_F , skin thickness, t_s , and hole spacing, s by the following equation:

Hole Diameter, $D = 4.572 \times 10^{-3} \text{ m}$ (0.18 inch)
Fuselage Radius, $R_F = 1.905 \text{ m}$ (75 inches)
Hole Spacing, $s = 25.4 \times 10^{-3} \text{ m}$ (1 inch)
Skin Thickness, $t_s = 7.62 \times 10^{-4} \text{ m}$ (0.03 inch)
Fuselage Pressure, $p = 0.0586 \text{ MPa}$ (8.5 psi)

Following a linear-elastic finite element analysis, the proportionality factors, A_1 , A_2 , and A_3 are calculated to be 9.35×10^{-1} , $3.44 \times 10^{-4} \text{ m}$, and $4.72 \times 10^{-4} \text{ m}$, respectively, for Hole No. 6. Also given are the following geometric parameters:
